# APPLICATION OF GEOSYNTHETICS AND EVALUATION OF WATER QUALITY IN AN ARTIFICIAL LAKE IN HARRAN UNIVERSITY, TURKEY

Artificial Lake; geosynthetics; water quality; Osmanbey Campus Lake.

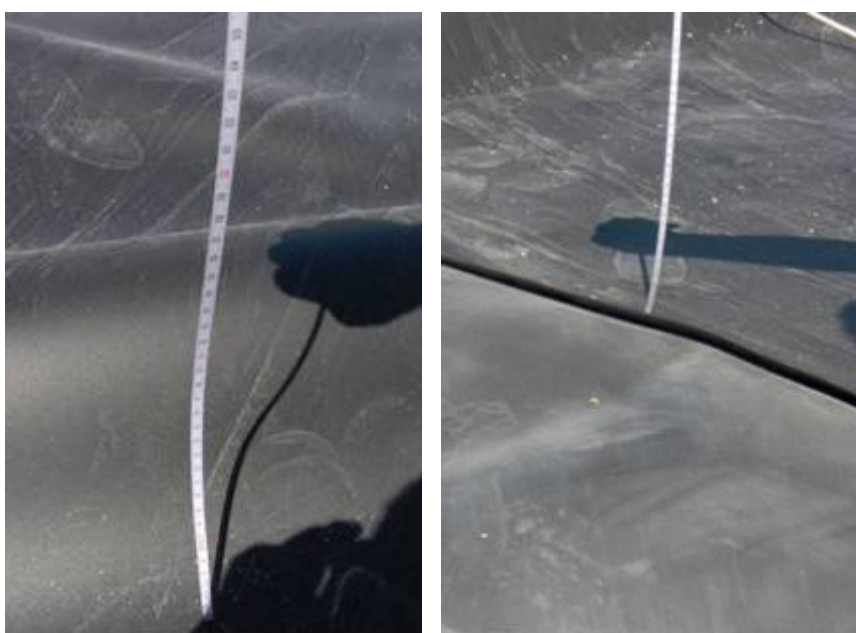
FIGURE 7 - Measurement of shape deformation of geomembrane due to delay of concrete covering.

If there is a delay in cover concrete productions over the geomembrane due to the elongation, there is a defor-

mation of 20 cm, and at some extreme cases, this deformation even reaches 30 cm, especially during summer when the temperature is at its maximum level. Measurement of this change is shown in Fig. 7.

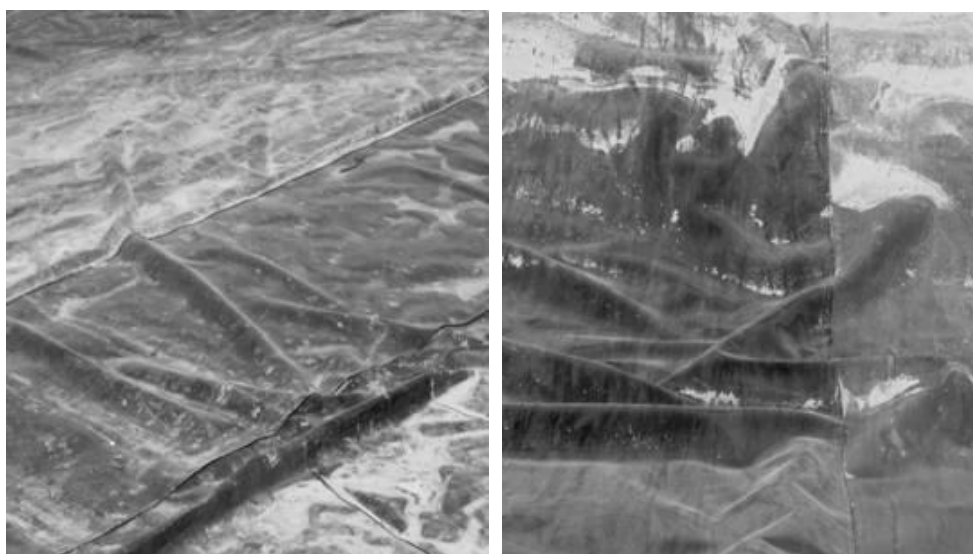
FIGURE 8 - Elongation of geomembrane due to shape deformations based on climatic conditions.

Geomembranes have technical stretching properties of 80% vertically and horizontally, elongation and shrinkage, due to the temperature differences between day and night. If the concrete structures are not placed at the same time together with geomembrane, it may take time to get weak concrete, and due to the temperature changes, there may be skids and cracks at concretes based on geomembrane shape deformation.
